# Estates and Facilities Alert

Ref: EFA/2011/004 (UPDATE)

High-Voltage (HV) 11KV Switchgear –  
Schneider Electric (Merlin Gerin) Ringmaster  
RN2c, RE2c and RN6c ring main units

**Product Safety Notice Reference Number: PSA-111201-318**

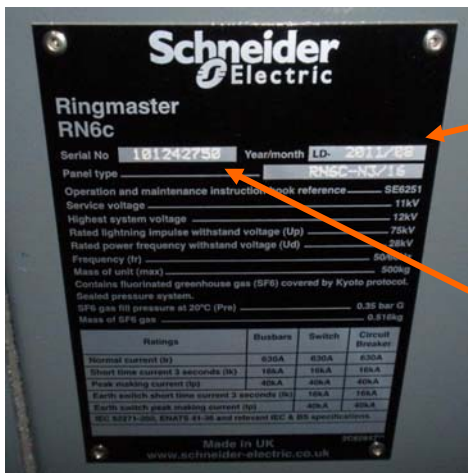
Data plate on the LV cabinet of the Ringmaster

The date of manufacture and serial number can be found on the product data plate on the front of all the Ringmaster ring main units. Refer the photo below.

Year and month of manufacture

Serial number

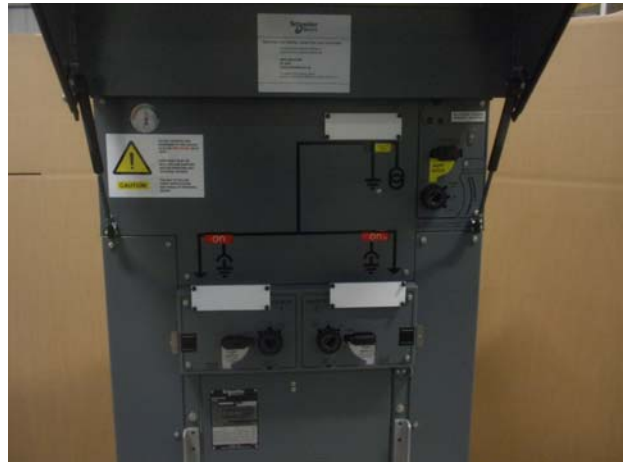
4.2 Ringswitch I and 2

**Do not operate the either of Ringswitch mechanisms from their current service position**

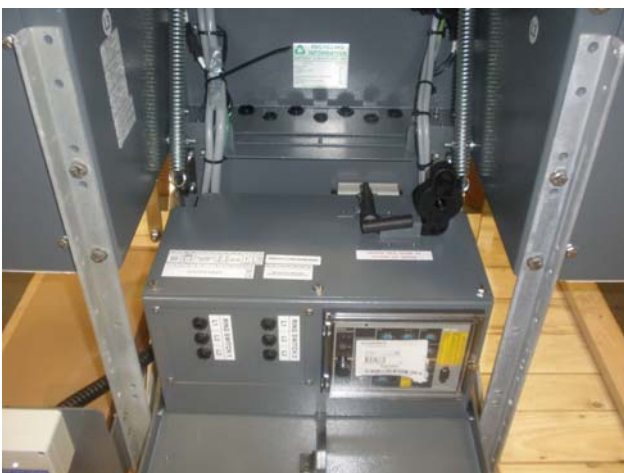
4.3 Open the LV cabinet and search for loose pieces of hardware in all accessible locations

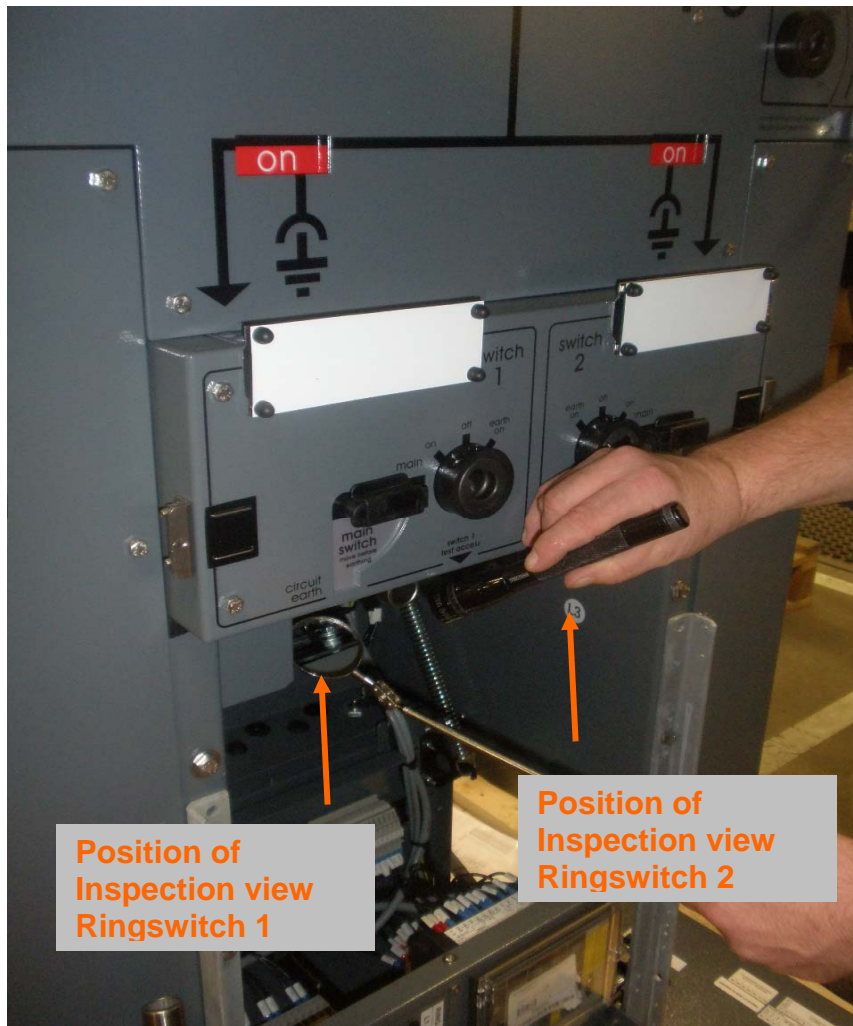
4.4 Check the parts to be inspected are still correctly located in Ring switch 1 drive shaft using a mirror and torch

4.5 Repeat the check for the correct location of hardware on Ring switch 2

**If any of the parts to be inspected described below cannot be seen or is not in the positions shown in the photos STOP and DO NOT operate the Ringmaster.**
