**Reinforced Autoclaved Aerated  
Concrete (RAAC) in NHS Estate:  
Management and Monitoring**  
Scottish Health Technical Note

**SHTN  
00-05**

Version 1.0 - July 2025

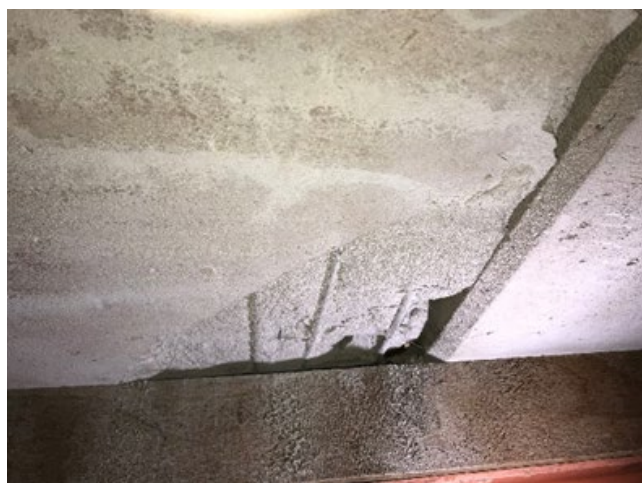
Figure 3.1 - Distressed end bearing

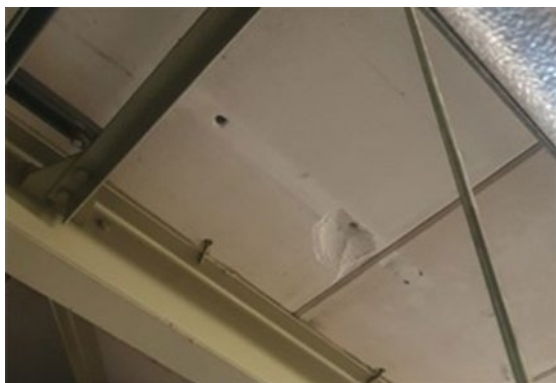
Figure 3.2 - Soffit spall

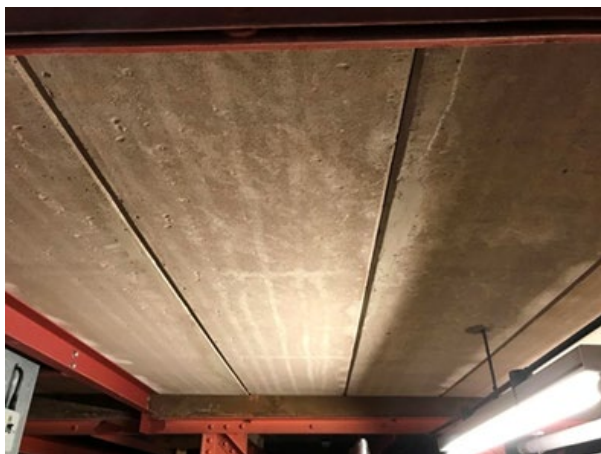
Figure 3.3 - Soffit discolouration indicating low cover

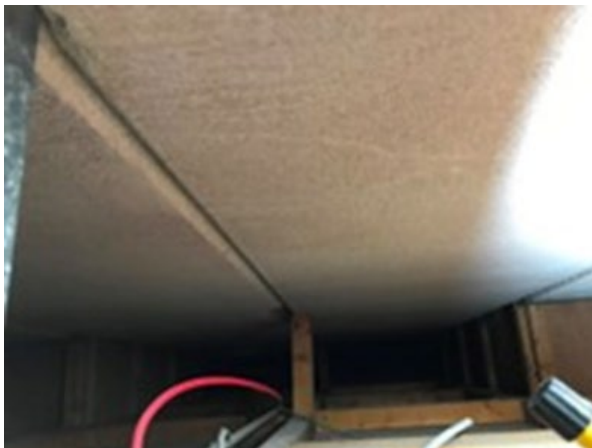
Figure 3.4 - Differential deflection between RAAC planks

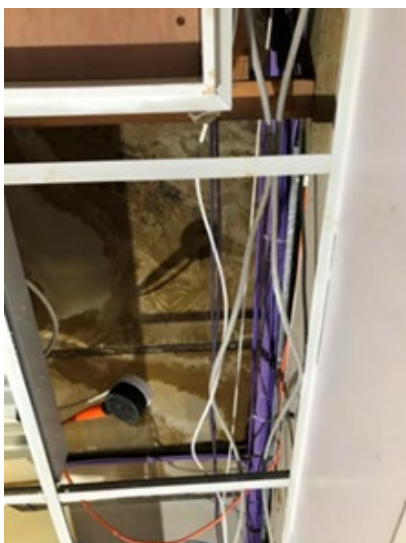
Figure 3.6 - Chronic water penetration to slab soffit

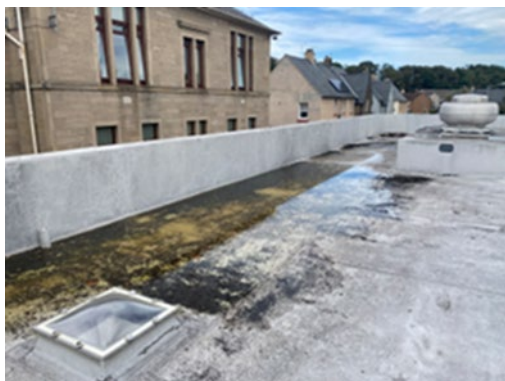
Figure 3.7 - Water ponding on roof

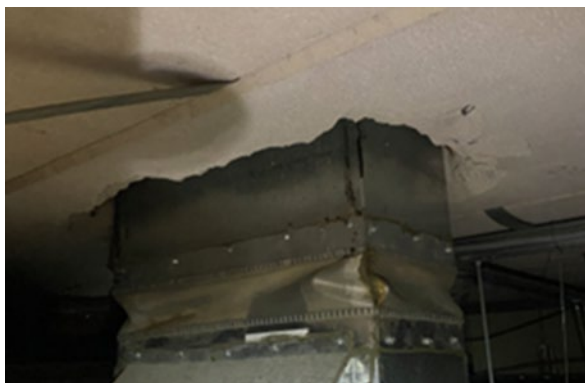
Figure 3.8 - Service penetration in the end of RAAC plank

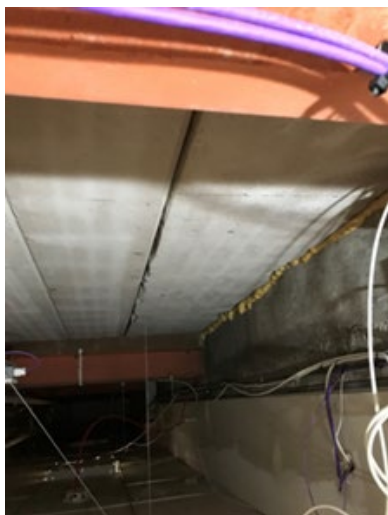
Figure 3.9 - Edge of RAAC plank site cut to fit outturn dimension

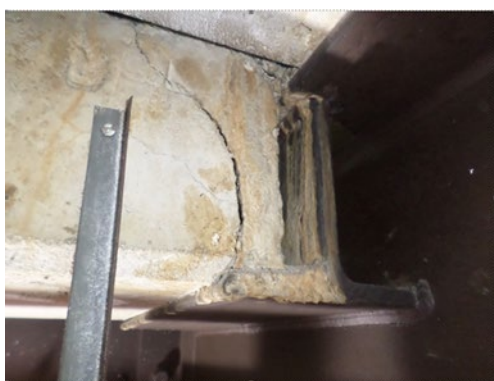
Figure 3.10 - RAAC plank cut short to sit on shelf angle has cracked bearing

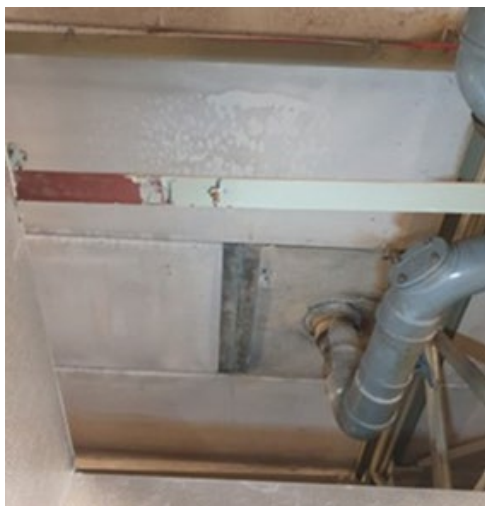
Figure 3.11 - RAAC plank cut short and supported on folded strap

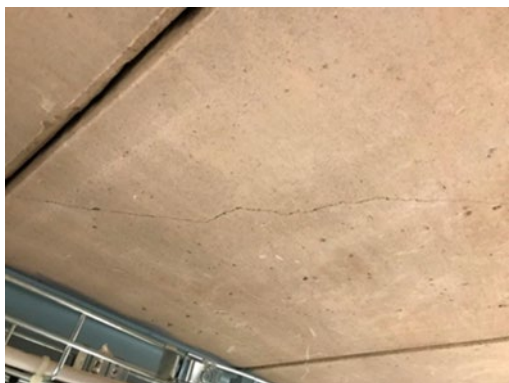
Figure 3.12 - Soffit cracks caused by plant loading above

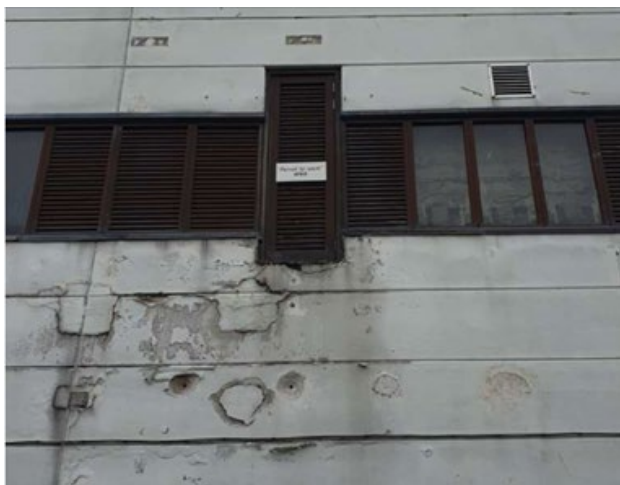
Figure 4.6 - Distressed cladding panels

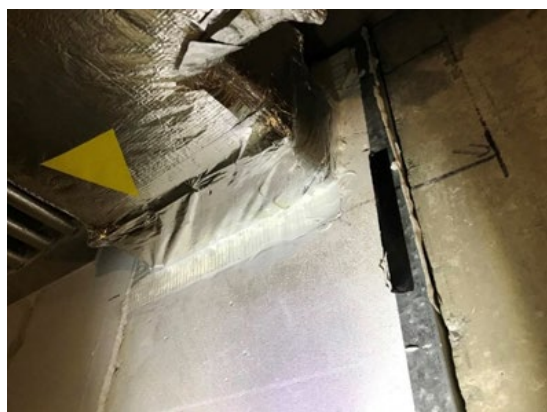
Figure 4.8 - Alteration to an internal partition

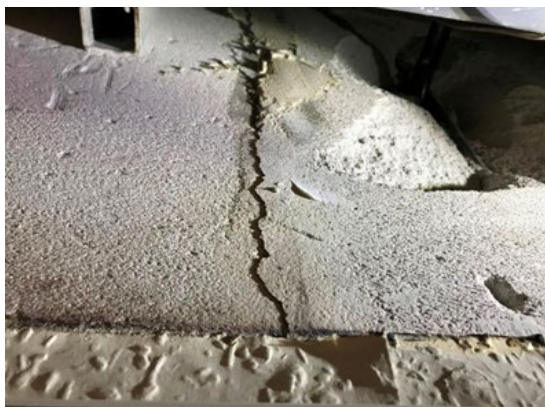
Figure 4.9 - Cracked infill joint between partitions

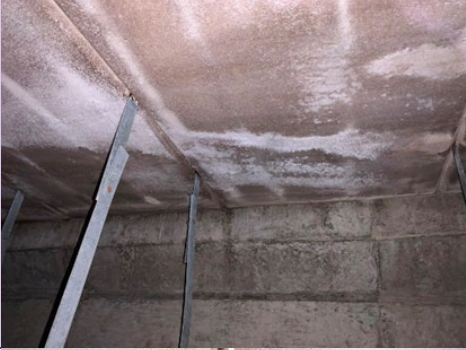
| Example Image | Observations | RAG Rating |
|---|---|---|
| | <ul style="list-style-type: none"> <li>water penetration collecting in voids around reinforcement and creating efflorescence on the soffit. The location is close to support, however deflection is not excessive and there is no cracking or spalling, although the conditions exist for expansive corrosion of the reinforcement and increasing the plank weight</li> <li>strictly speaking the IStructE classification is Amber, because there is no distress, but due to the extent of penetration, there is a reasonable expectation of distress forming. Red may be more appropriate</li> </ul> | Amber |

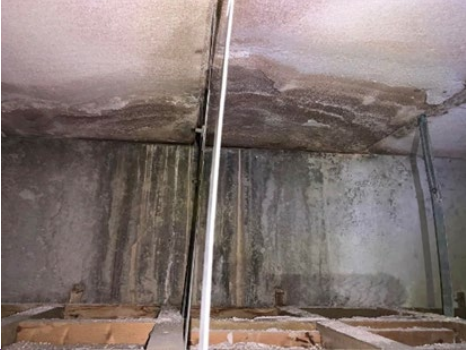
| Example Image | Observations | RAG Rating |
|---|---|---|
| | <ul style="list-style-type: none"> <li>water penetration close to the support, causing efflorescence, and erosion, to the soffit</li> <li>deflection is not excessive</li> <li>the conditions exist for expansive corrosion of the reinforcement and increasing the plank weight</li> </ul> | Red |

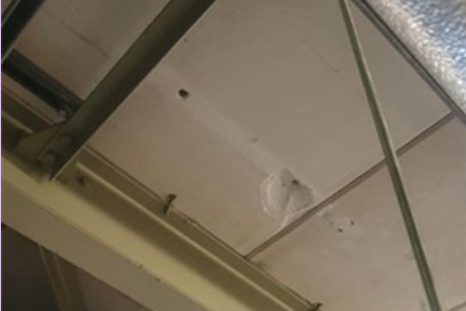
| Example Image | Observations | RAG Rating |
|---|---|---|
| | <ul style="list-style-type: none"> <li>• a soffit fixing has been pulled from slab causing a spall. Although close to support, the plank is dry, has no flexural cracking or excessive deflection and no reinforcement is visible</li> <li>• providing the action is not repeated, the damage should not become worse</li> </ul> | Amber |

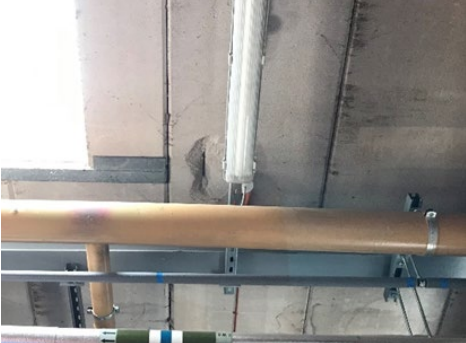
| Example Image | Observations | RAG Rating |
|---|---|---|
| | <ul style="list-style-type: none"> <li>• a deep spall, with reinforcement exposed, can be seen</li> <li>• the plank is dry, has no flexural cracking or excessive deflection, suggesting the spall is not stress induced</li> <li>• the end of the support strap is located next to the spall, which implies an uncontrolled installation of the plank that has been cut short</li> <li>• providing the action is not repeated, the damage should not become worse, albeit the spall should be repaired to protect the reinforcement</li> </ul> | Red |

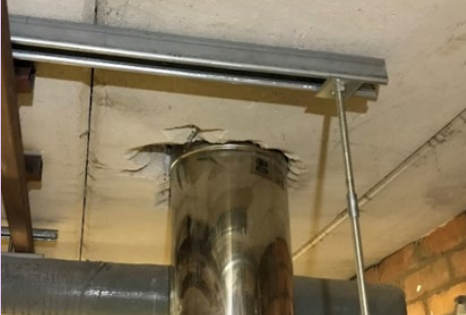
| Example Image | Observations | RAG Rating |
|---|---|---|
| | <ul style="list-style-type: none"> <li>• a large penetration in the middle of a plank, although remote from the supports</li> <li>• while spalled at edges, probably due to the method used to cut the hole, there are no flexural cracks. The plank is dry and deflection is not excessive</li> <li>• although the damage is unlikely to be repeated, the capacity of the plank has been materially diminished</li> </ul> | Red |

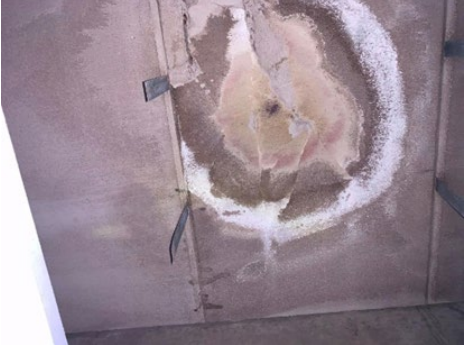
| Example Image | Observations | RAG Rating |
|---|---|---|
| | <ul style="list-style-type: none"> <li>• water penetration close to the support, causing efflorescence and cracking on the soffit, probably due to expansive corrosion</li> <li>• reinforcement is locally visible</li> <li>• the deflection is not excessive</li> </ul> | Red |

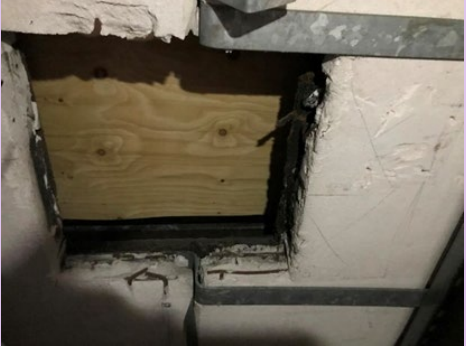
| Example Image | Observations | RAG Rating |
|---|---|---|
| | <ul style="list-style-type: none"> <li>• opening in slab, remote from the support, carried on the adjacent plank using folded plate straps. The adjacent plank has been cut near the bearing for the folded plate straps. The adjacent plank has been cut near the bearing for the folded plate straps</li> <li>• no flexural cracks are seen but the slabs' flexural capacity has been diminished</li> <li>• planks are dry and deflection is not excessive</li> </ul> | Red |

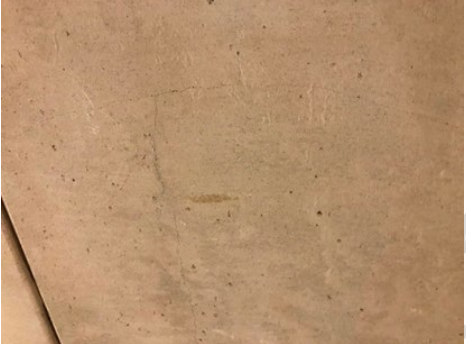
| Example Image | Observations | RAG Rating |
|---|---|---|
| | <ul style="list-style-type: none"> <li>• minor cracking near the middle of planks due to the weight of air handling plant placed on top</li> <li>• plank is dry and deflections are not excessive</li> <li>• the air handling plant could be moved or spread over more planks</li> </ul> | Green |

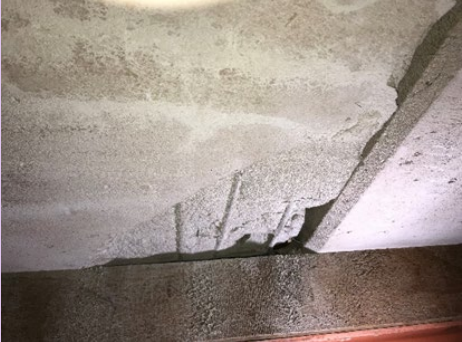
| Example Image | Observations | RAG Rating |
|---|---|---|
| | <ul style="list-style-type: none"> <li>spalled soffit near support, likely caused by rough handling during installation, but otherwise sound when tested</li> <li>longitudinal and transverse reinforcement visible and present over support</li> <li>dry and no excessive deflection</li> </ul> | Red |

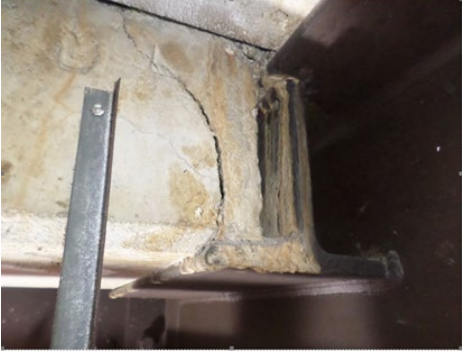
| Example Image | Observations | RAG Rating |
|---|---|---|
| | <ul style="list-style-type: none"> <li>major crack at the plank bearing, probably caused by a modification intended to shorten the plank so that it could bear onto a ledger (made of an inverted tee) fixed to the primary steelwork</li> </ul> | Red (critical) |

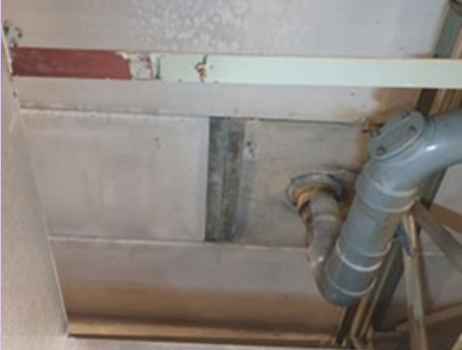
| Example Image | Observations | RAG Rating |
|---|---|---|
| | <ul style="list-style-type: none"> <li>plank end cut short to make room for a rainwater pipe. The cut plank is supported on a folded metal strap. A second strap supports the in-situ infill</li> <li>the plank is dry, the deflection is not excessive and there is no cracking or spalling</li> </ul> | Amber |

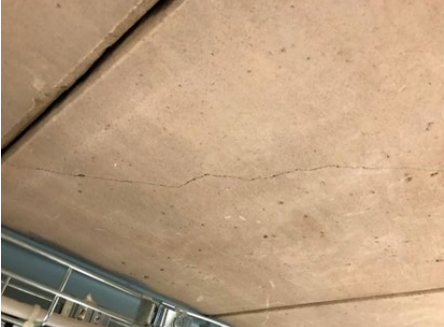
| Example Image | Observations | RAG Rating |
|---|---|---|
| | <ul style="list-style-type: none"> <li>• minor cracking that begins near the support and is due to the weight of air handling plant placed on top</li> <li>• plank is dry and the deflection is not excessive</li> <li>• the air handling plant could be moved or spread over more planks</li> </ul> | Amber |

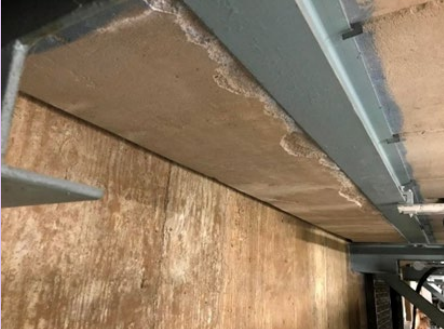
| Example Image | Observations | RAG Rating |
|---|---|---|
| | <ul style="list-style-type: none"> <li>• the plank forming gutter has been modified to fit between the façade and the nearest supporting beam. This has caused spalling to the inside edge. Post installation there is no reason for this damage to be repeated</li> <li>• the plank is dry, there are no stress induced cracks or spalls, and the deflection is not excessive</li> </ul> | Amber |

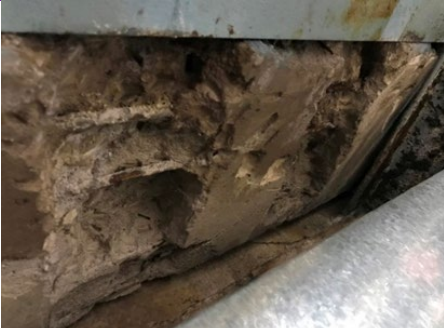
| Example Image | Observations | RAG Rating |
|---|---|---|
| | <ul style="list-style-type: none"> <li>• the soffit of this plank, which forms a roof gutter, has been heavily damaged with percussive tools and reinforcement is exposed to view. The damage is close to the support, although the plank is dry and there are not any cracks induced by stress. The plank has not deflected excessively</li> <li>• given the location, and the position of rainwater pipes out of picture, it is likely that the damage was caused by an attempt to create a new rainwater outlet, which was abandoned in progress</li> </ul> | Red |

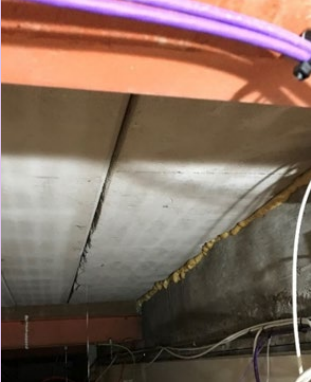
| Example Image | Observations | RAG Rating |
|---|---|---|
| | <ul style="list-style-type: none"> <li>the end plank has lost its bevelled edges and has rough edges. This implies that it has been modified, probably because it did not fit the out-turn dimension to the adjacent wall</li> <li>the plank is dry, does not have cracks or spalls and has not deflected excessively</li> <li>there is also discolouration on the plank soffit that appears to correspond to the position of reinforcement within the plank. This is discussed in the example below</li> </ul> | Amber |

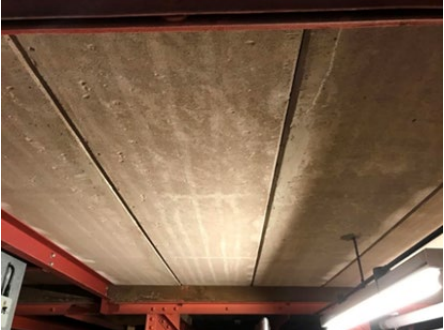
| Example Image | Observations | RAG Rating |
|---|---|---|
| | <ul style="list-style-type: none"> <li>discolouration on the plank soffit corresponds to the position of longitudinal and transverse reinforcement. Shallow cover likely caused differential curing relative to neighbouring concrete. Fire resistance will be reduced, although roofs are seldom compartment floors. Low cover is not unique to RAAC; it is often present in conventional concrete until the 1980's</li> <li>the plank is free from cracks and spalls, has not deflected excessively, and is dry</li> </ul> | Green |

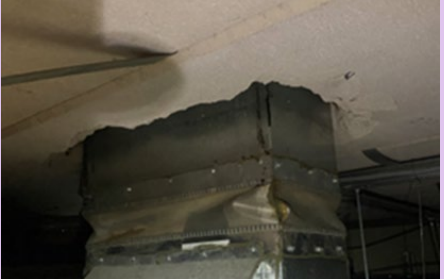
| Example Image | Observations | RAG Rating |
|---|---|---|
| | <ul style="list-style-type: none"> <li>approximately two thirds of the plank width have been removed near mid span. The hole edges have spalled, due to the method of cutting, but cracks induced by stress are not evident. The plank is dry and does not appear to have deflected excessively</li> <li>nevertheless, the capacity of the plank has been materially reduced</li> </ul> | Red |

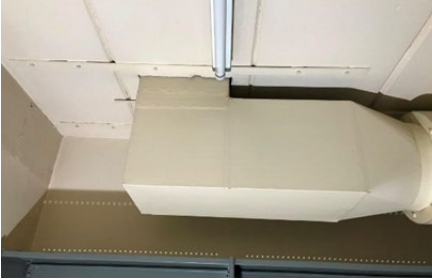
| Example Image | Observations | RAG Rating |
|---|---|---|
| | <ul style="list-style-type: none"> <li>more than two thirds of the plank width have been removed near the support. The hole edges are neatly cut, and there are two straps framing the hole. The magnitude of their contribution is not clear, as bolts in RAAC have limited capacity, but spalling and cracks induced by stress are not evident. The plank is also dry and does not appear to have deflected excessively</li> <li>nevertheless, the capacity of the plank has been materially reduced</li> </ul> | Red |

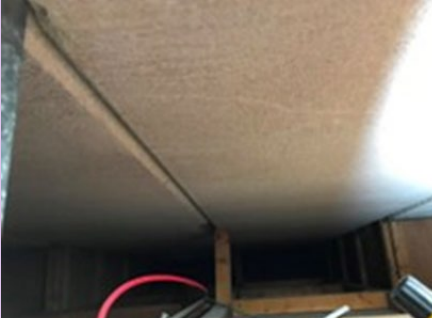
| Example Image | Observations | RAG Rating |
|---|---|---|
| | <ul style="list-style-type: none"> <li>the planks are dry and are not cracked or spalled, however they have deflected differentially, although not by much. This could be a difference in manufacturing or something else going on. For this reason, it would be sensible to monitor movements</li> </ul> | Amber |

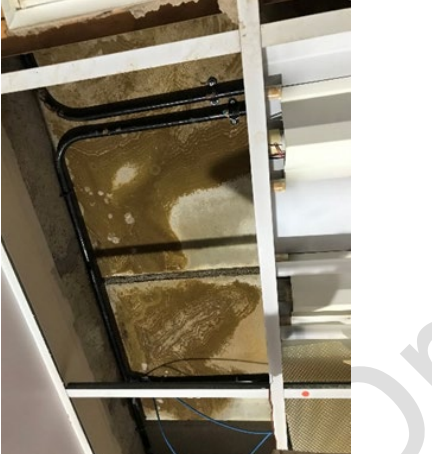
| Example Image | Observations | RAG Rating |
|---|---|---|
| | <ul style="list-style-type: none"> <li>chronic water penetration is evident near the plank supports, suggesting a significant failure of the roof coverings and rainwater goods. This does not appear to have resulted in expansive corrosion, cracking/ spalling, but the conditions now exist for that to happen. If the planks become saturated generally, the weight of the planks could also become important</li> <li>the planks have not deflected excessively and have not spalled</li> <li>strictly speaking the IStructE classification is Amber, because there is no distress, but due to the extent of penetration, there is a reasonable expectation of distress forming. Red may be more appropriate</li> </ul> | Amber |

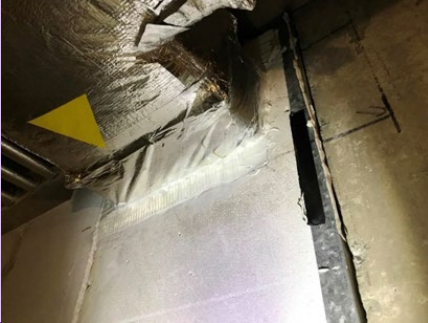
| Example Image | Observations | RAG Rating |
|---|---|---|
| | <ul style="list-style-type: none"> <li>a modification at the head of an existing non-loadbearing partition prevents it spanning vertically from floor to soffit, as intended. There is a vertical track tying the right-hand edge to the adjacent column and the butt joint to the left is filled and is intact. The partition remains plumb and is inferred to be spanning horizontally</li> <li>since its stability relies on the integrity of an unreinforced joint it would be better to restore restraint at the top of the partition</li> </ul> | Red |

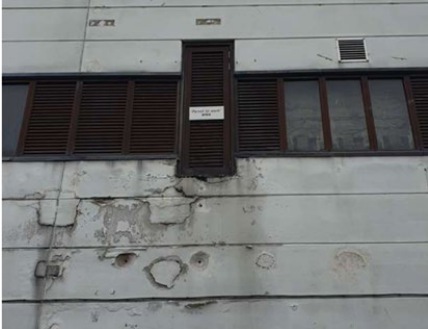
| Example Image | Observations | RAG Rating |
|---|---|---|
| | <ul style="list-style-type: none"> <li>there is lots of surface damage, probably due to old fixings, and water damage, due to the surface coating being compromised. There are several openings that influence the ability of planks to span horizontally between steel columns, although the wall remains plumb, and the horizontal joints remain tight. No out of plane slippage can be seen between planks. Corrosion of embedded fixings is a risk if water penetration continues. Distressed areas are a debris risk and ought to be fixed</li> </ul> | Red |
