**Reinforced Autoclaved Aerated  
Concrete (RAAC) in NHS Estate:  
Management and Monitoring**  
Scottish Health Technical Note

**SHTN  
00-05**

Version 1.0 - July 2025

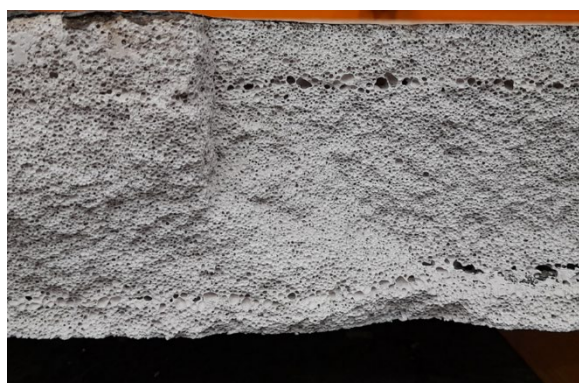
Figure 2.3 - Shadow effect around reinforcement (page 4, 'Reinforced Autoclaved Aerated Concrete (RAAC) Panels Investigation and Assessment', IStructE, February 2022)

- 2.13. Another characteristic of RAAC, shown in Figure 2.3, is the 'shadow effect' which occurs when gas bubbles, due to the foaming process, form voids around the reinforcing bars. The size of the voids is thought to depend upon the bar diameter and will tend to reduce the bond between AAC and embedded reinforcement. Figure 2.4 below also shows the variability in voids throughout the AAC.

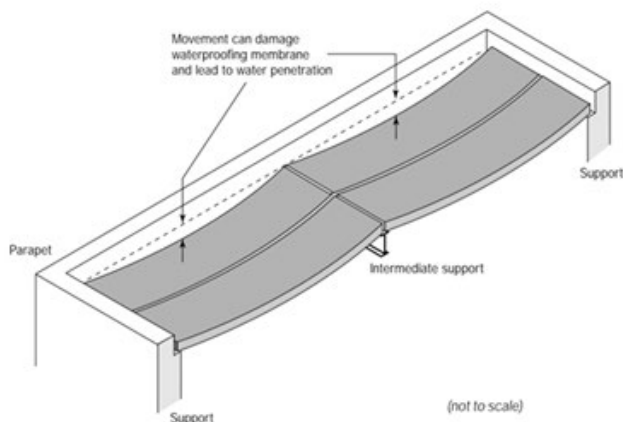
Figure 3.5 - Risk to finishes from deflection (page 3, 'IP 10/96 - Reinforced Autoclaved Aerated concrete planks designed before 1980', Building Research Establishment (BRE), December 1996)

- 3.29. Where excess deflection occurs next to static elements of the structure, for instance, adjacent to a parapet or gable wall, the roof finishes are vulnerable to splits and tears, which have the potential for water to penetrate (refer to Figure 3.5 below). Another example would be above primary beams that provide support to deflected planks.

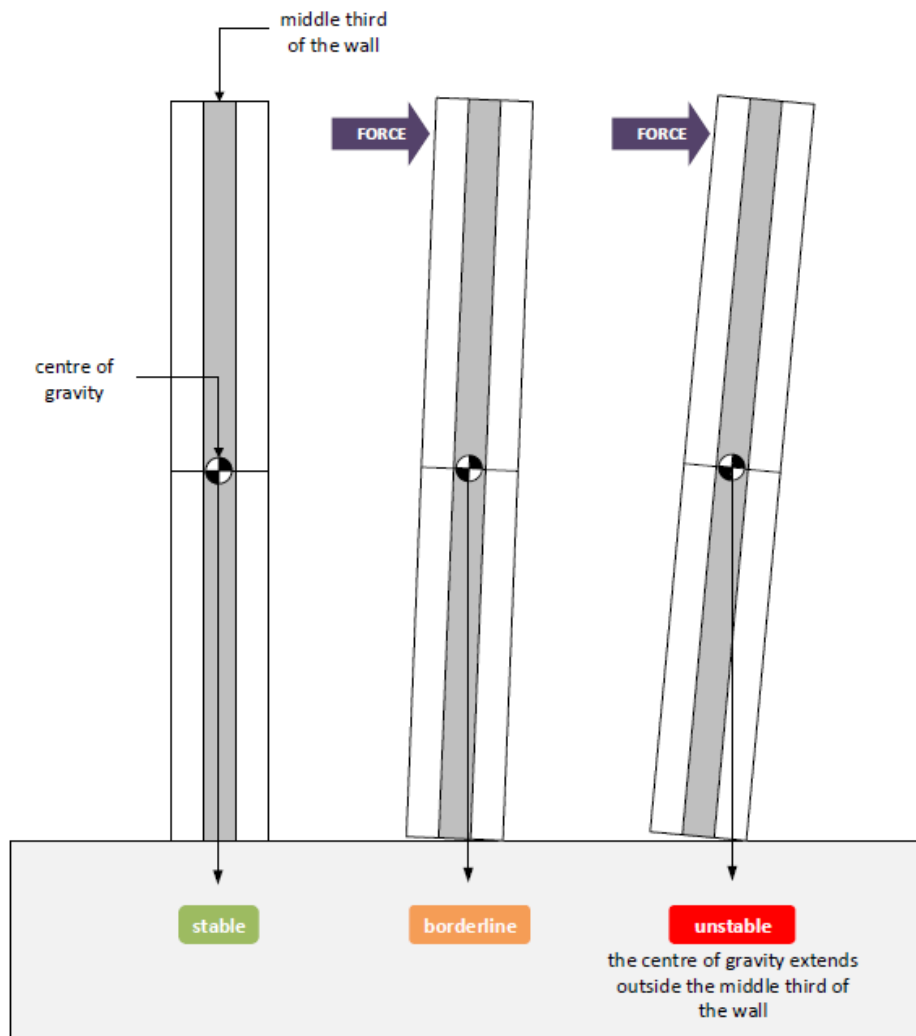
Figure 4.5 - Middle third concept diagram

- 4.19. An accepted rule of thumb for Structural Engineers when they assess the vertical stability of solid walls is to maintain their centre of gravity within the middle third of their thickness. It is proposed that walls out with this limit be classified as 'red'. That said, the presence of hooks tying the planks laterally to supporting columns, mitigate this risk by enabling them to span horizontally.

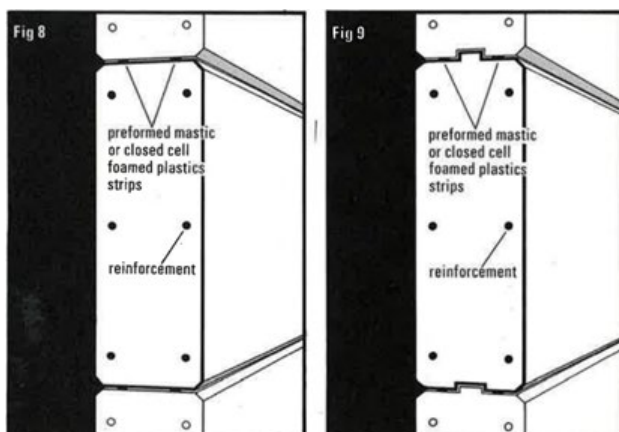
Figure 4.7 - Siporex and Durox cladding panels

- 4.22. Conversely, the Siporex system did not have a 'tongue and groove' detail and would therefore be more vulnerable to distress near the top of a wall, where there would be less weight acting on joints and therefore less friction between panels. Evidence of differential displacement between planks or vertical separation, in combination with a large penetration or cracking, would be classed in the 'red' category, especially near the top of a wall. In the absence of displacement or separation the 'amber' category may be appropriate, providing the height of wall above the penetration is sufficient to generate frictional resistance.
